Investigation of material deterioration and seismic behavior of Fertek and Hançerli Churches in Cappadocia Region

Metin Hakan Severcan¹

^{1,4} Niğde Ömer Halisdemir University, Civil Engineering Department, 51240, Niğde Turkey

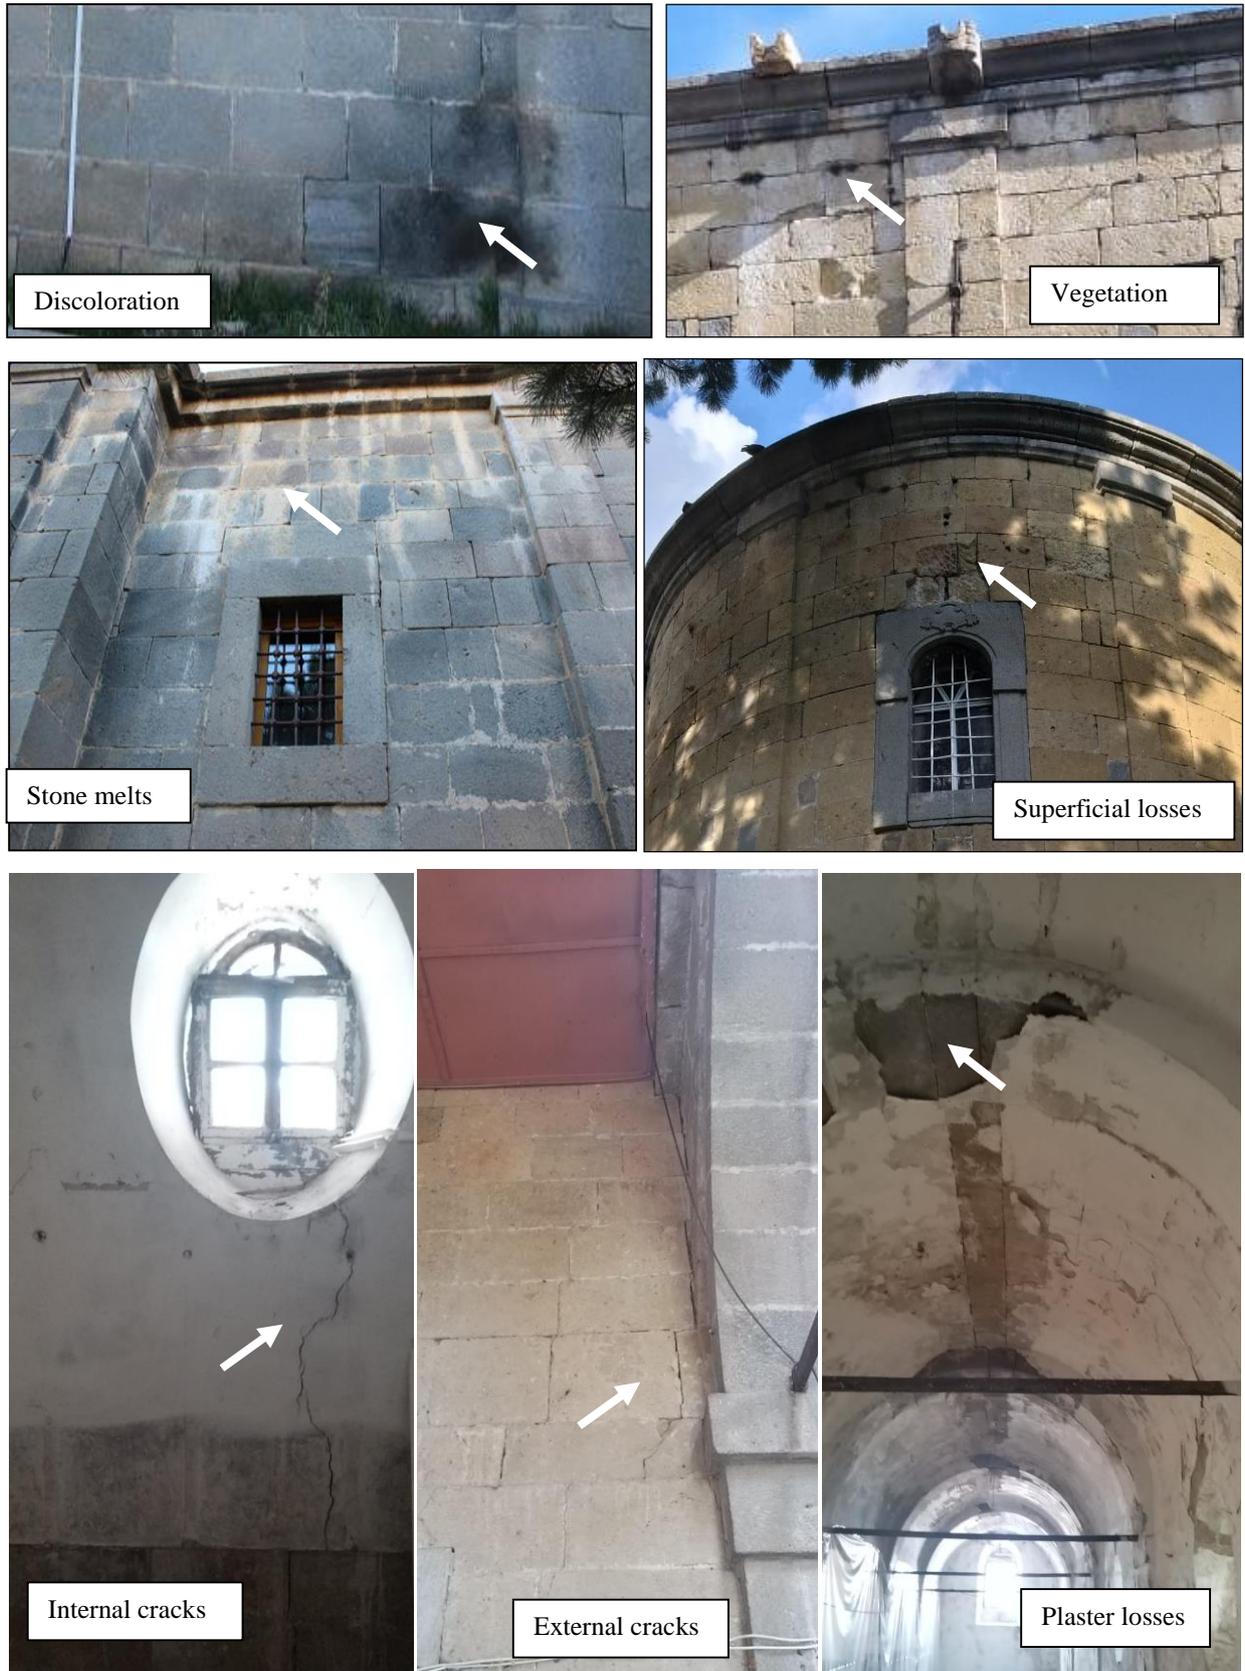
Fertek Church has survived to the present day while preserving its structural system characteristics. No large cracks are detected that could affect the structural system. Partial stone deterioration occurs due to natural conditions. Especially discoloration has occurred in the stones close to the ground level and the stones under the cornices due to moisture and rainwater. Efflorescence that is a result of the evaporation of the salts carried in the rising moisture from the floor on the surface of the wall may cause deterioration

of the physical and chemical properties of the wall. In addition, superficial spill and stone losses are formed due to moistening in the ignimbrites. Also, another problem that is seen between the joints on the exterior is vegetation. Other problems such as stone cracks, stone melts and plaster losses are also detected in the structure (Figure 5).

Figure 5. Deterioration problems at Fertek Church.

It is important to solve the moistening problems in both monumental structures. Because water is the main factor in physical, chemical, and biological degradation processes in stones [15]. This problem causes a decrease in the strength of the walls which is one of the important elements of the structural system of the building, and poses a threat to the life of the building. Salt and other substances carried by rainwater and ground water entering the stones cause chemical deterioration especially due to the moisture effect [16]. In order to solve the humidification problem road level should be lowered especially in Hançerli Church.

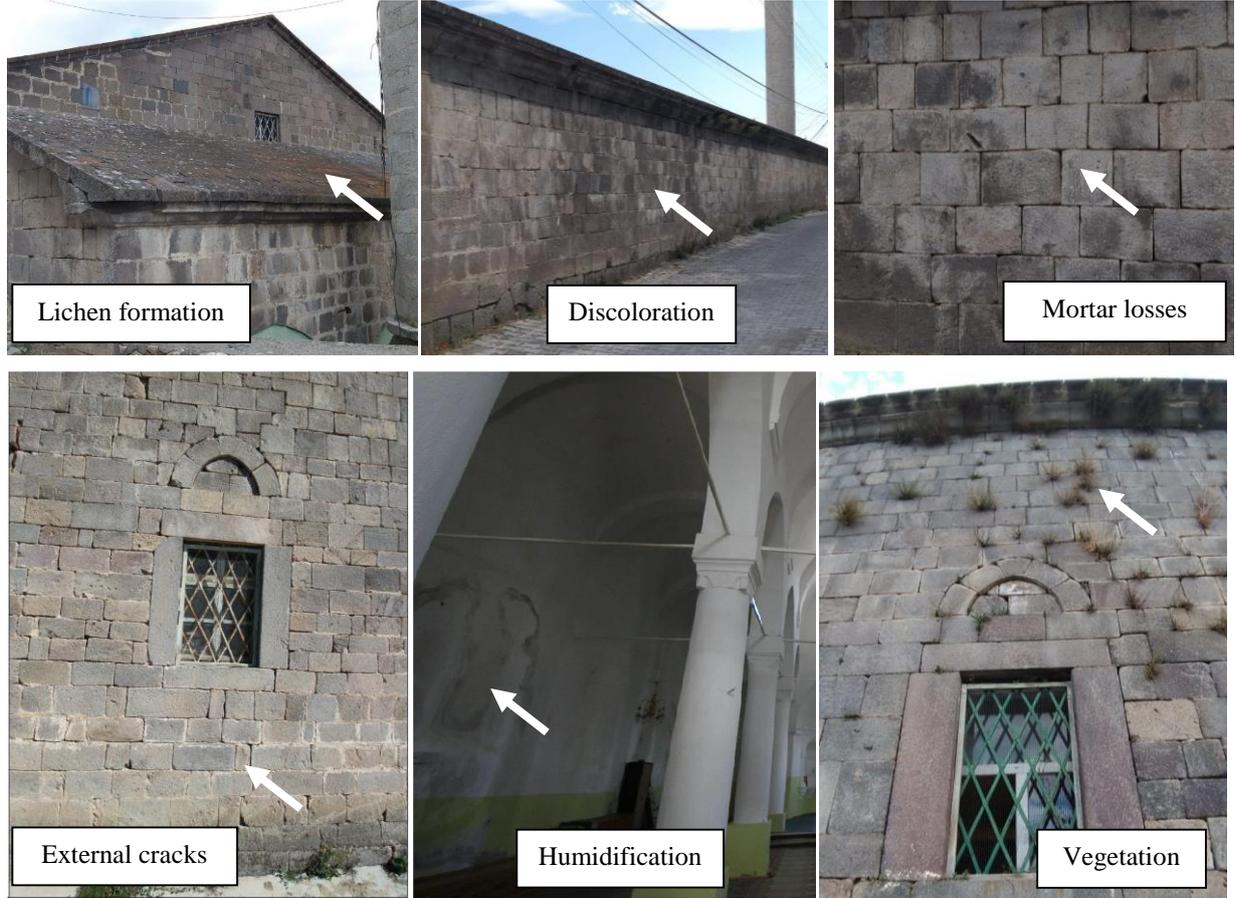
Hançerli Church which is built on the platform formed by the retaining walls due to the slope has survived to the present day by preserving its structural system properties to a great extent. One of the problems observed in the structure is that the northern front leans against the road elevation at a high elevation. This causes the vibrations on the road to be transmitted to the structure and creates a dynamic effect. In addition, the building which is located on a sloping topography is exposed to rain and snow waters coming from the upper road. This situation causes moisture problems in the structure. The stones have been damaged by moisture which can lead to a decrease in strength. In addition, because of the accelerating effect of water on biological degradation, lichen formation on the stone roof at Hançerli Church is observed [8,14]. There are no large cracks in the building that could affect the structural system. Similar to the Fertek Church, there are problems such as mortar losses, stone cracks, humidification problems and vegetation due to the natural conditions (Figure 6).

Figure 6. Deterioration problems at Hançerli Church.

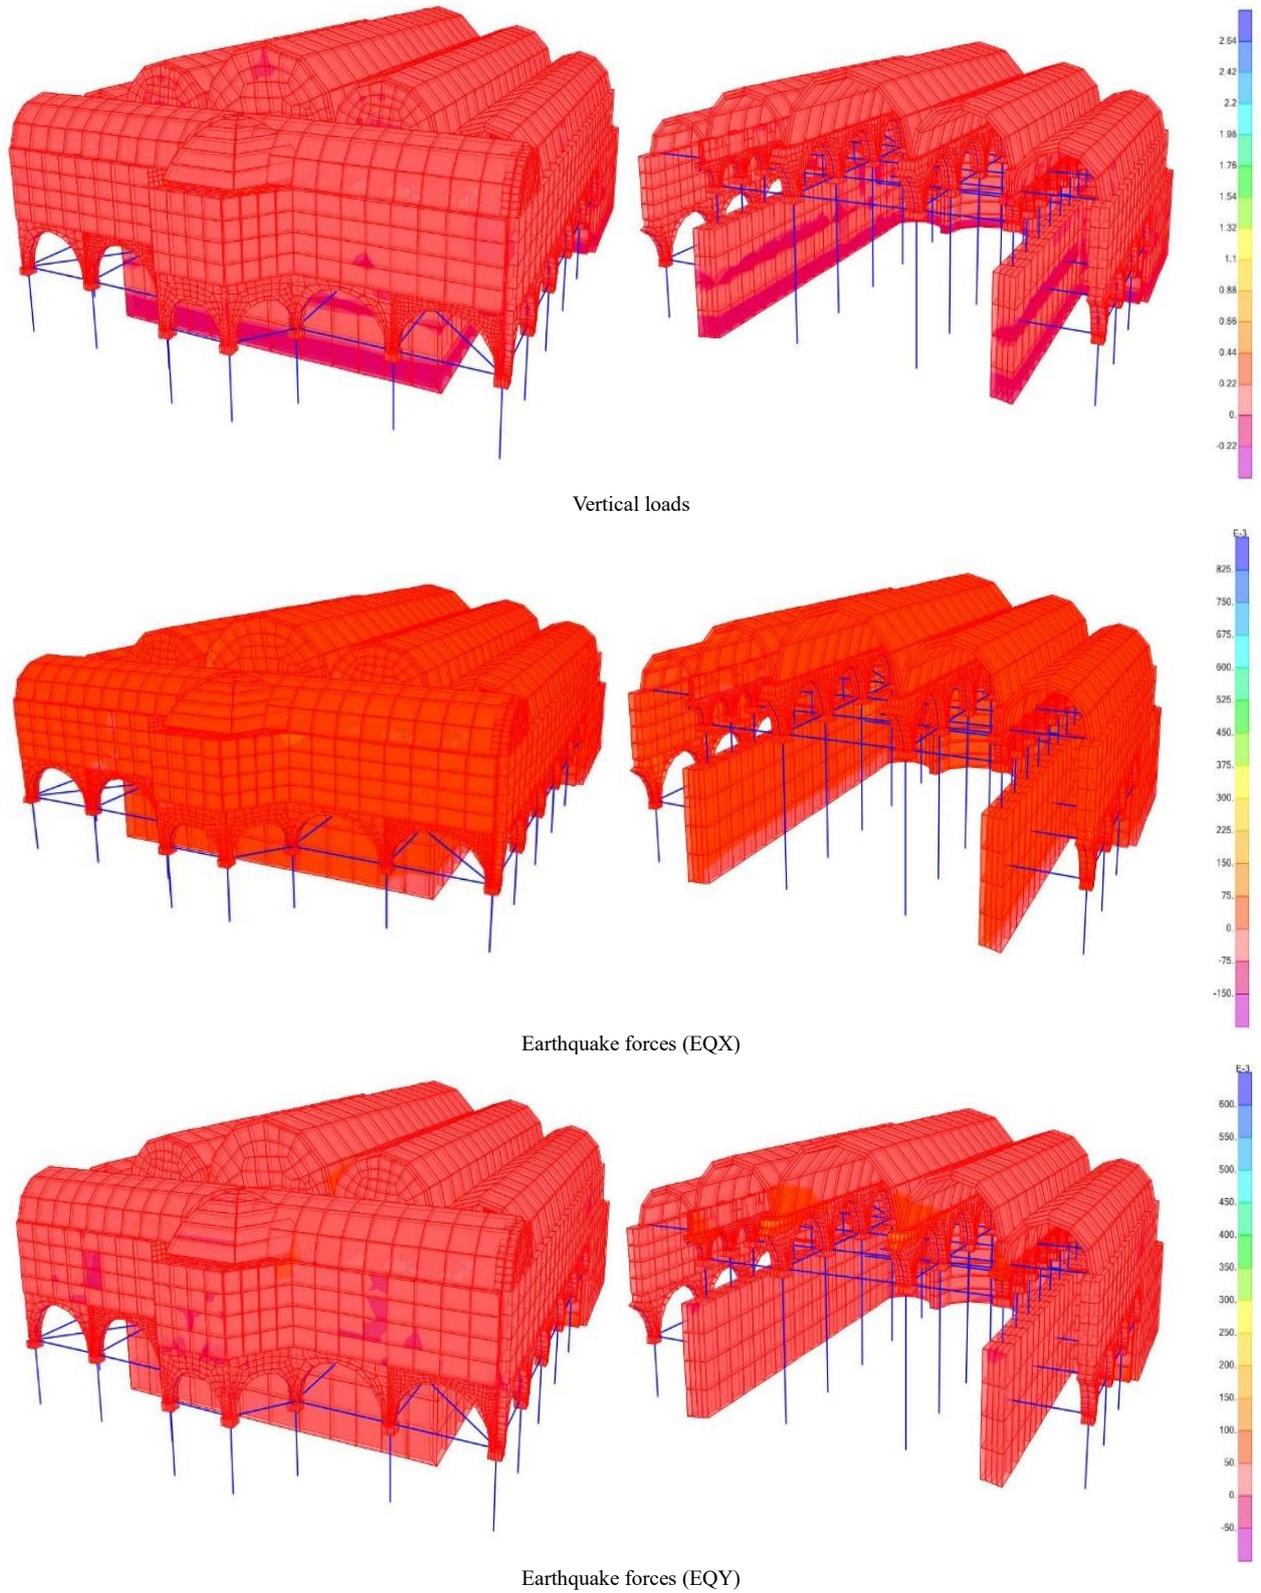
It is seen that the maximum tensile stress in the Fertek Church is 2.537 MPa, the compressive stress is 0.424 MPa, and the maximum tensile stress in the Hançerli Church is 1.452 MPa and the compressive stress is 0.537 MPa. However, it is observed that the tensile stresses were less than 1 MPa for both monumental structures and that the maximum tensile stress values shown in Table 4 are exceeded only in a few regions of the corners of the wall cavities and the lower corners of the wall.

Since the compressive strength of the masonry structural elements is much higher than the tensile strength, the tensile stresses in which the monumental structure is weaker are evaluated together with the compressive stresses within the stress values obtained from the analysis. When the maximum compressive and tensile strength values of the structural elements given in Table 2 are compared with the maximum stresses in Table 4, it is seen that the compressive stresses are quite low compared to the compressive strength of the stones and the tensile stresses are lower than the tensile strength of the stones.

Figure 8. The stress distribution obtained as a result of static analysis of Fertek Church.

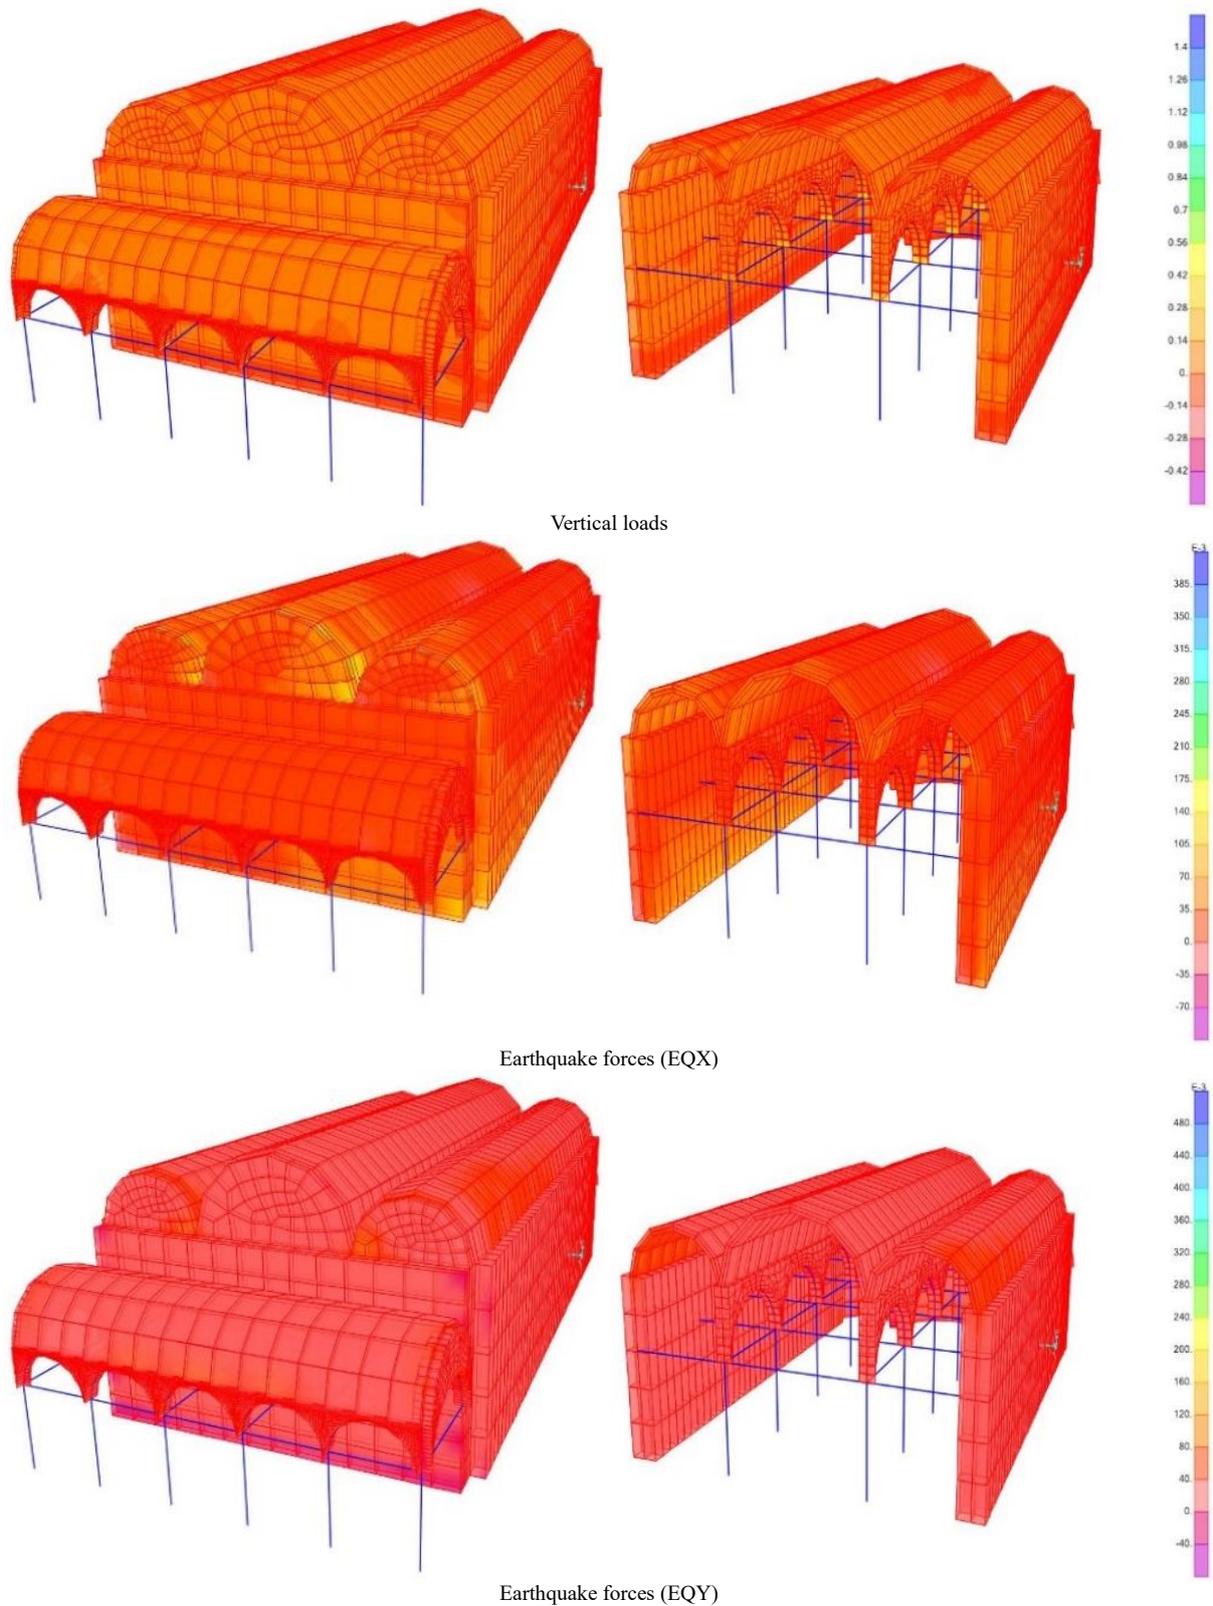
Figure 9. The stress distribution obtained as a result of static analysis of Hançerli Church.
