Material Characterization and Damage Assessment of Byzantine Rock-Cut Monastery: A Case Study of Kiyikoy Hagia Nicholas*

Abstract

Keywords: Byzantine rock-cut heritage, Damage, Material characterization, Chemical analyses, Holistic conservation

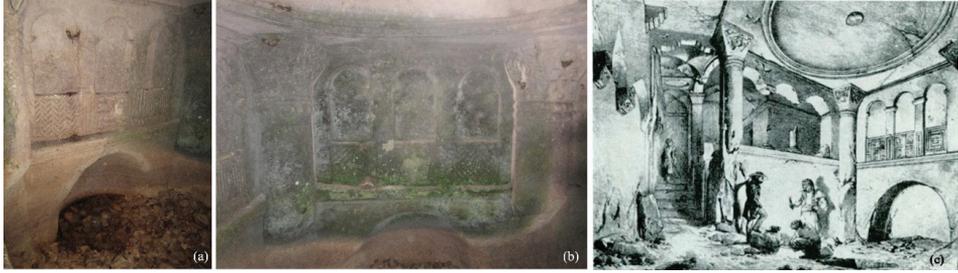
F. 6: (a) Eastern wall of holy spring and debris on the floor and in the eastern niche (Şerife Özata Archive, 2020) (b) Current situation of the southern niches and wall (Şerife Özata Archive, 2020) (c) Hell's engraving of the holy spring as viewed from the southwest of the holy spring (Semavi Eyice, *Trakya'da Bizans Devrine Ait Eserler*, 60.)

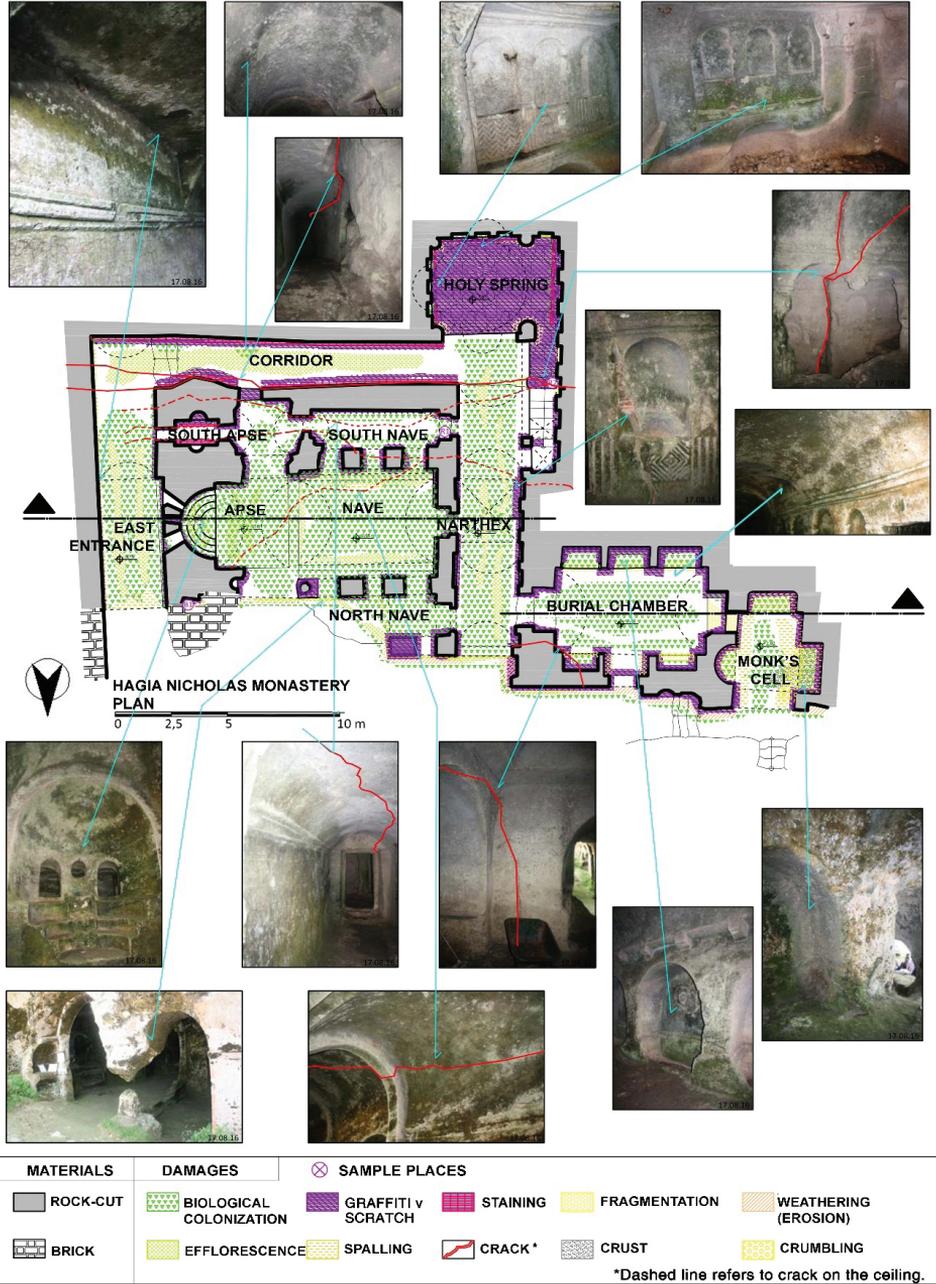
F. 12: Damages in the reflected ceiling plan of Hagia Nicholas Monastery (Prepared by Şerife Özata and Engin Aktürk)

Spalling, efflorescence and biological colonization like algae, lichens and mosses exist on the ceiling of the eastern entrance. Also, there is graffiti and scratching on the east and west walls of the (F. 12, F. 13). Staining is partly seen on the northern and southern walls of the corridor. There is biological colonization on some parts of

the southern wall that take sunlight. Cracks on the ceiling and floor are shown with a line in **F. 12** and crack on the ceiling are shown with the dashed line. Cracks in the corridor divide the building into two pieces. The crack widths start at 1 cm, and in some places, the width extends up to 25 cm and becomes a fracture.

The floor of the holy spring cannot be seen due to water and debris and destroyed pieces of corner columns. There are structural cracks and fractures on the floor and ceiling. They caused fragmentation on the eastern wall (**F. 12**) and at the bottom of the columns. Biological damages along with staining, efflorescence and spalling are seen on each wall of the holy spring.

ons on the ceiling and floor. Monk's cell does not have a north wall. All its walls, floor and ceiling have scratches, spalling and biological colonization. There is the crust and crumbling on its west wall (F. 12).

to rock formation, as in many rock-cut structures or an earthquake. Cracks can also trigger the mass falling of rock and fragmentation. Various damages around the crack also increase and expand the crack width. Endoscopic examination, georadar scans or motion meters can be performed periodically to monitor the structural crack mechanism. If the cracks are moving, additional structural elements made of materials compatible with the rock can be used. The use of steel materials in rock-cut structures is not recommended because the thermal expansion coefficients of steel and rock are quite different⁶³. If an addition is to be made, it should not threaten the historical building's authenticity, although it is physically connected to it⁶⁴. Fragmentation usually occurs around cracks. Therefore, it is necessary to intervene promptly to prevent the breakage of parts. In addition, rocks that are likely to break should be dropped in a controlled manner.

It is noteworthy that since the investigated structure was formed by carving a rock, any issues associated with the main rock directly impact the structure itself. This particular issue is unique to rock-cut structures and does not arise in any other structural systems. Therefore, when developing the proposal, the damage reasons identified in the first environment, the main rock, and the second environment around the rock should be taken into account. Since there is a layer of soil on the bedrock, the moisture in the soil is transmitted directly to the structure. Most of the recommended treatments for cleaning, consolidation and surface protection without cutting off this humidity supply will be the act of removing the symptom of the damage. To prevent the structure from water-induced damage, wells can be drilled around the structure and/or a waterproof layer created with natural or artificial materials may be designed to block the permeability of water between the bedrock and the topsoil.

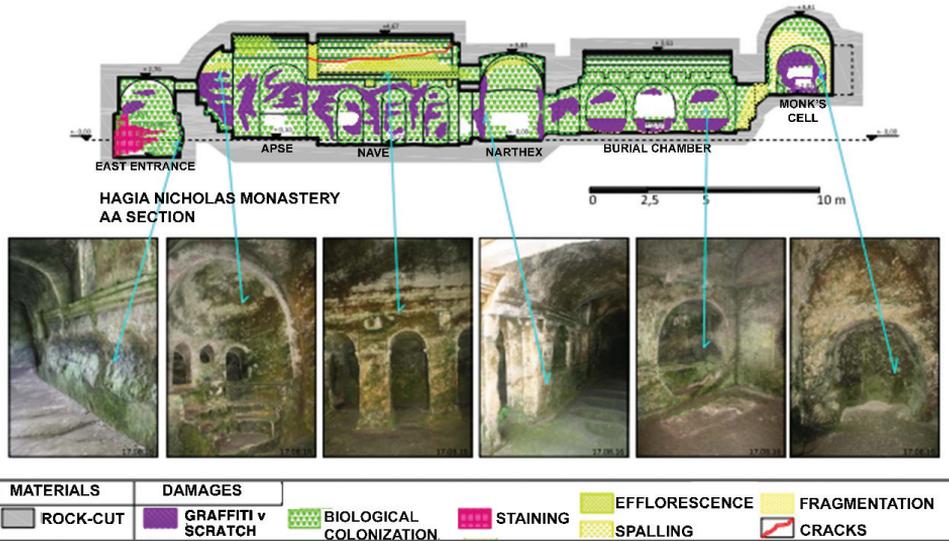
F. 13: Damages in the section of Hagia Nicholas Monastery (Prepared by Şerife Özata and Engin Aktürk)

Destruction, spalling and biological colonization are seen on the columns and walls of all naves. Devastated parts are generally in the north nave. The bottom of the one column in the north of the nave and some part of the floor is destroyed and fragmented. There are efflorescence and cracks on the ceilings of the naves. Wild vegetation exists on the floor (**F. 12**). Walls and ceilings of the apses have efflorescence, biological colonization and scratches (**F. 13**).

There are rectangular graves on the floor of the narthex. Eastern and western walls, ceilings and floors have cracks, biological colonization and efflorescence and scratches are seen on these walls (F. 12, F. 13).
