Tree-Structure Relationship in Landscape Design and Management

Citation: Korkmaz, C., Saydam, G. & Şahin Ş: (2023). Tree-structure relationship in landscape design and management. *Journal of Architectural Sciences and Applications*, 8 (Special Issue), 604-614.

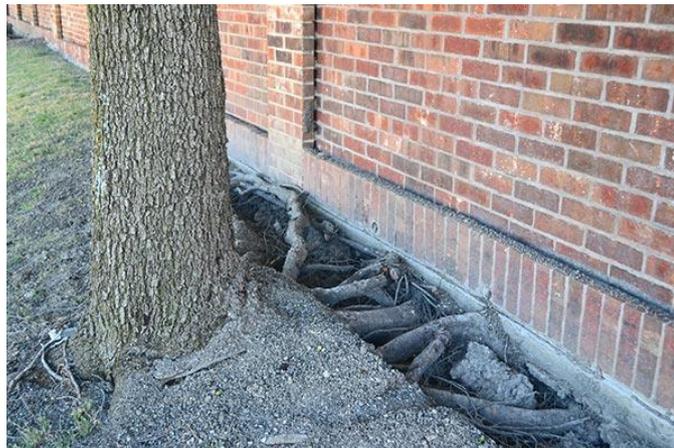
Figure 6. Tree roots growing under foundations (CNT Foundations, 2020)

Although tree roots are often considered the cause of damage to buildings' foundations, they rarely constitute the primary source of the problem. While small roots can penetrate existing cracks in foundations, their growth does not typically lead to mechanical damage. However, soil subsidence can indeed cause harm to buildings (Mercer, Reeves & O'Callaghan, 2011). While the roots themselves may not directly harm buildings and foundations, increasing soil movement can endanger the integrity of the soil on which the building rests and its supporting structure. Consequently, if the soil moves, everything resting on it will also move (Figure 6) (Satriani, Loperte, Proto & Bavusi, 2010).

The damage frequently occurs in "concrete settlement". When concrete settles, the possibility of shifting and cracking increases. Depending on the magnitude of the movement, the overall structure of the building can be affected. Support beams may shift, walls may collapse or crack, and ceilings may become unsteady (Satriani, Loperte, Proto & Bavusi, 2010).
