Investigation of material deterioration and seismic behavior of Fertek and Hançerli Churches in Cappadocia Region

Metin Hakan Severcan¹

^{1,4} Niğde Ömer Halisdemir University, Civil Engineering Department, 51240, Niğde Turkey

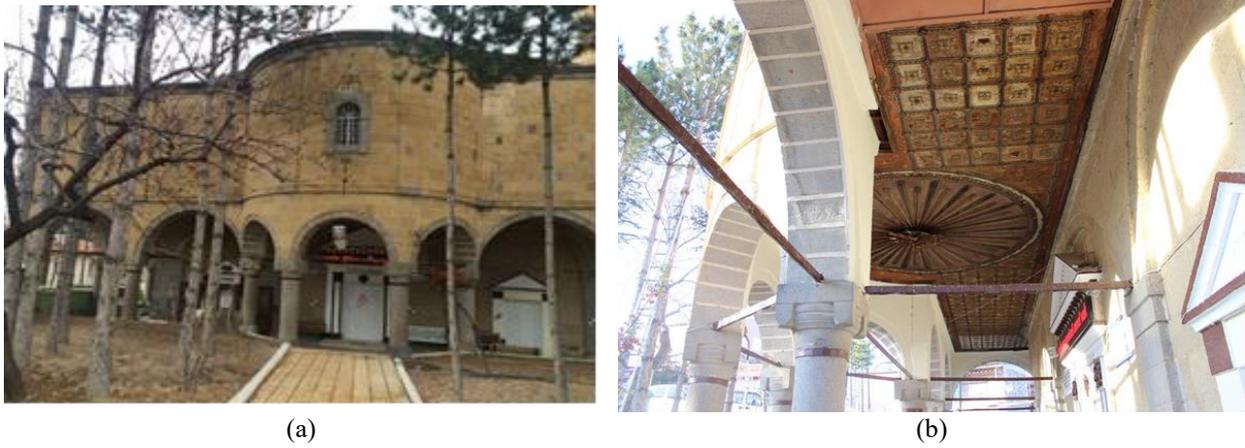
Figure 1. Fertek Church (a) front facade (b) narthex ceiling

In Fertek Church, wall thicknesses are ranging from 80-110 cm on the ground floor and between 70-85 cm on the upper floor. Gray-black and yellow cut stones of Cappadocia Region are also used on the facades of Fertek Church (Figure 1).

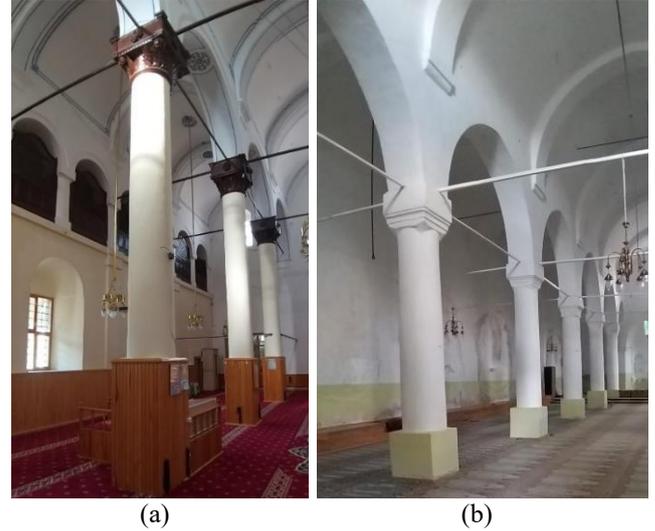
Figure 4. The column bases in Fertek (a) and Hançerli (b) Churches

The wall thickness of the Hançerli Church varies between 65-120 cm. Due to the thickness of these stone walls which are continuous elements that transmit the loads coming from the structure to the foundation, the tensile stresses due to the load are minimized and the compressive stresses are increased at the same rate. In all facades of the Hançerli Church gray-black andesite and basalt stones unique to Cappadocia Region are used (Figure 3). Because these stones are highly resistant to external factors, the buildings that are built with these stones have survived for many years. The columns of the buildings are presented in Figure 4.

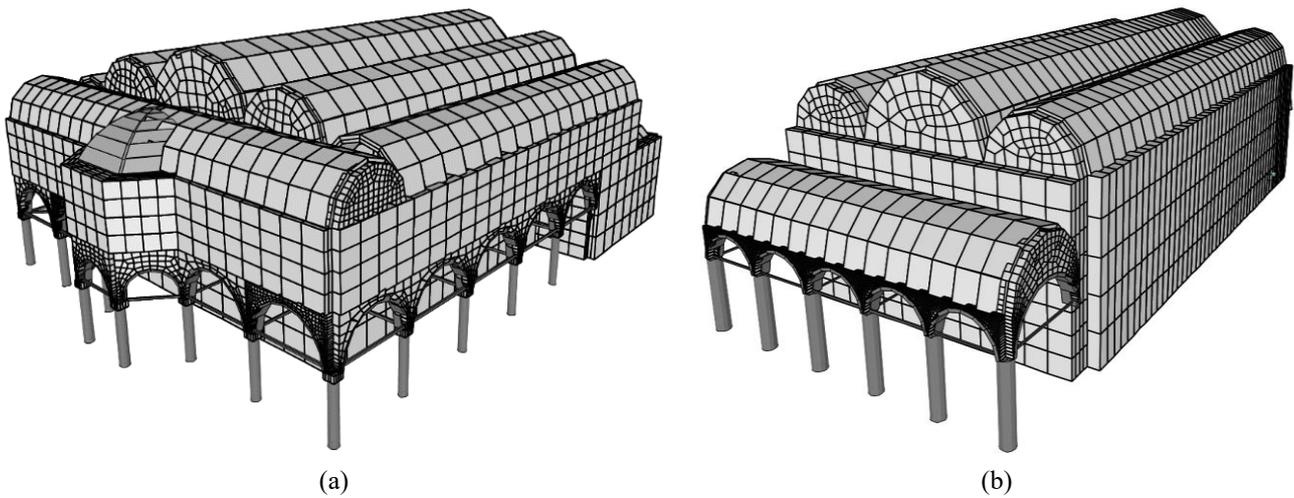
Figure 7. 3D finite element models of (a) Fertek, (b) Hançerli Churches.

It is seen that the maximum tensile stress in the Fertek Church is 2.537 MPa, the compressive stress is 0.424 MPa, and the maximum tensile stress in the Hançerli Church is 1.452 MPa and the compressive stress is 0.537 MPa. However, it is observed that the tensile stresses were less than 1 MPa for both monumental structures and that the maximum tensile stress values shown in Table 4 are exceeded only in a few regions of the corners of the wall cavities and the lower corners of the wall.

According to the data given in Table 4, both Fertek and Hançerli Churches are found to have more difficulty under vertical loads than earthquake effects. However, when compared with the allowable stress values of the stones, it has been found that both structures can resist the tensile and compressive stresses occurring on them without any damage.
