Material Characterization and Damage Assessment of Byzantine Rock-Cut Monastery: A Case Study of Kiyikoy Hagia Nicholas*

Abstract

Keywords: Byzantine rock-cut heritage, Damage, Material characterization, Chemical analyses, Holistic conservation

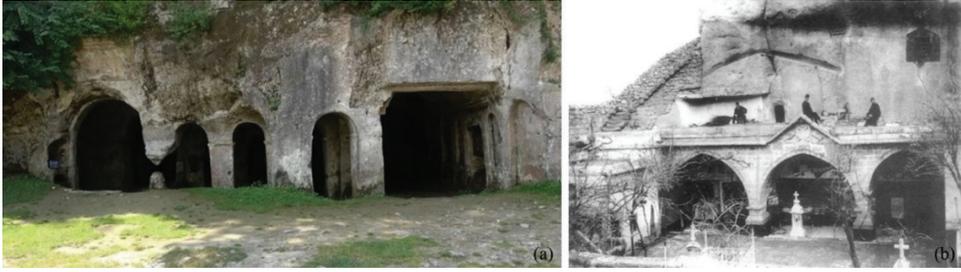
F. 4. (a) Kiyikoy Hagia Nicholas Monastery façade (Şerife Özata Archive, 2020) (b) Nevsehir Hagia Nicholas Monastery (1924) (<https://mustafapasakapadokya.org/en/yapilar/st-nicholas-monastery-and-church>)

The present basilical plan and cross-section are illustrated in **F. 5**. The temple was formed by carving massive rock, and some ceilings were carved as barrel vaults. Unlike the main rock-hewn structure, the porticoes were constructed of stone and brick as masonry. The flat brick patterns, which were generally used in the Byzantine Period and are still found in the remaining masonry on the north. The dimensions of the bricks could not be determined exactly, but they were in the form of flat bricks in the vault and the form of rectangular prisms on the walls. Almost all of these masonry exterior sections were demolished.

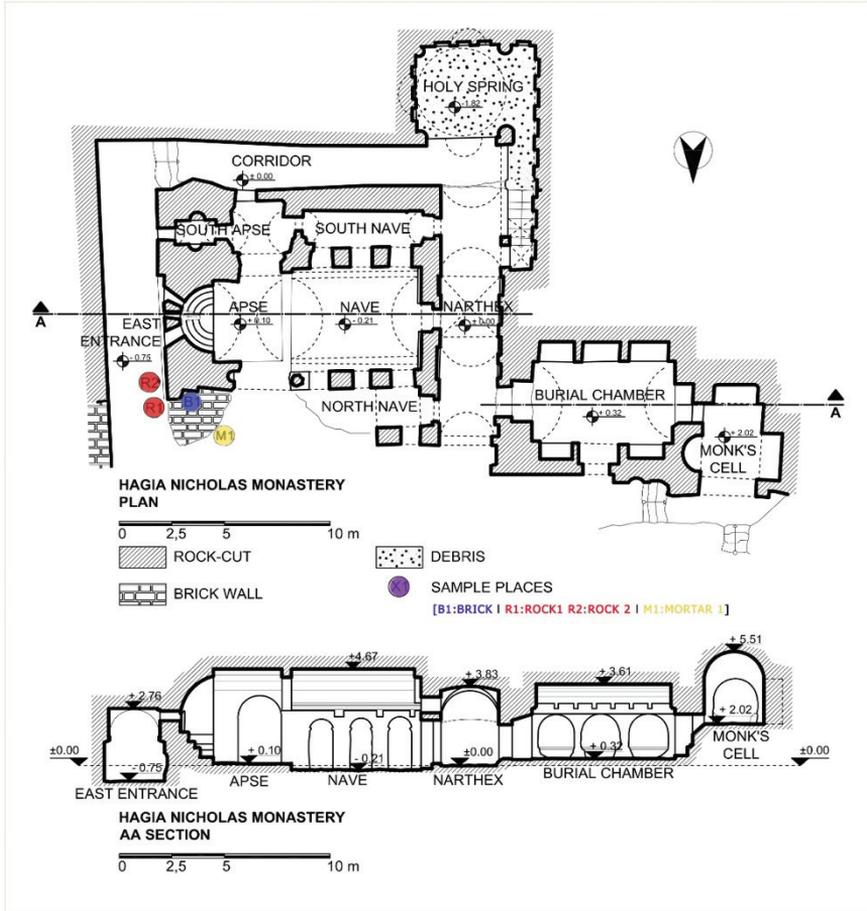
F. 5: The up-to-date plan and section of the monastery (Drawn by Engin Aktürk and Şerife Özata, 2023)

The main church is on the east side of the narthex. The church has a basilical plan with three naves and three apses. Of the three apses, the one to the north is destroyed. The large nave measures 6×5 m and the others are approximately $5.75 \text{ m} \times 1.80$ m in rectangular plan (**F. 3**). The naves end with the apse in the east, and a synthronon (rows designed for religious officials to sit) can be seen in the apse. There are three windows in the Byzantine style above these rows. The middle window is round, the side windows are rectangular and larger than the middle one. All these windows open to the east entrance. Dirimtekin²⁶ stated that there is an inscription between the windows, but it is not seen currently due to the biological damage. The north wall of the north aisle has collapsed and its remains are missing. It is thought that this wall may have been destroyed by an earthquake or since it was built with bricks that are not as strong and durable as the rock, it was destroyed over time.

There is a narthex to the west of the naves. The burial chamber is accessed through a door on the eastern wall of the narthex. Dirimtekin¹ defined this door as a window. The burial chamber measures approximately 4 m × 6.8 m. There is an apse on the west wall of the room and a total of five niches on the north and south walls. There is a door opening to the outside between the two niches on the north wall. It is possible to enter the monk's cell through the window in the niche on the west wall (F. 5).

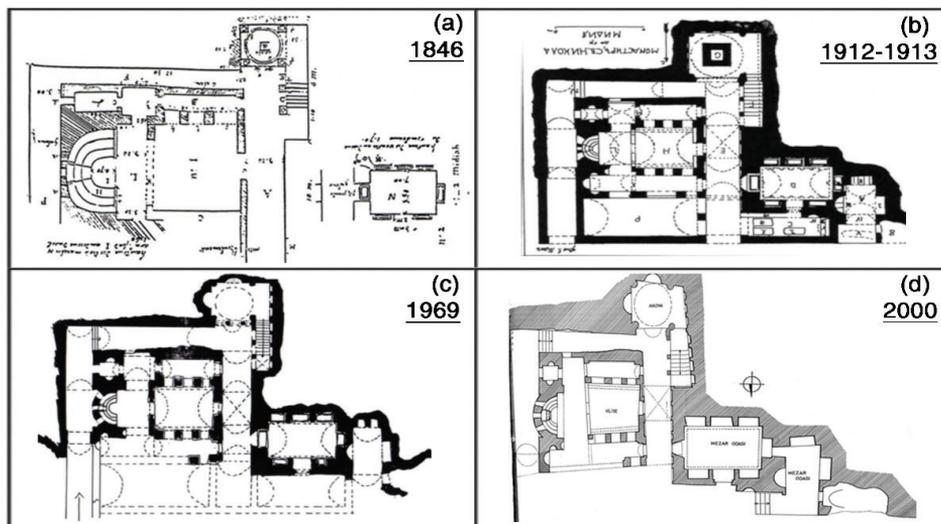
Over time, the plan and layout of the monastery underwent alterations due to both natural causes and human-induced effects. In the archival research carried out to understand the causes and stages of the partially damaged condition of the monastery, a detailed written source could not be found. From 1846 to 2000, various researchers/travellers drew up the plan of the monastery. The previously drawn plan sketches and brief explanations about them are presented in **F.7**. When these sketches are examined, it is understood that the northern facade was not destroyed until 1912-1913. Although some figures are seen in the holy spring in the sketches of Hell and Skorpil seen in **F.7a** and **F.7b** respectively, they are not seen in later drawings. Semavi Eyice sketched by specifying the destroyed parts in 1969. The structural system and damaged parts in **F.7c** and **F.7d** are almost identical to those in the current plan in **F. 5**. It is thought that the reason for the damaged parts may have been the earthquake in Edirne in 1953²⁹. Also, climatic effects, disasters and human-induced damages are other probable reasons for this destruction.

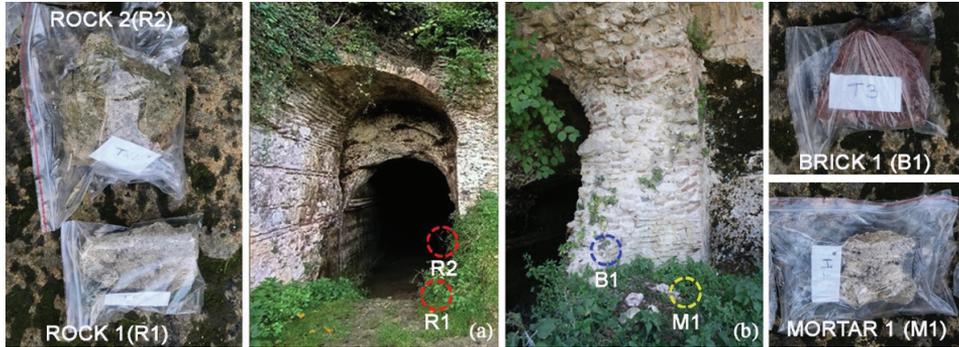
F. 8. (a) Location of a rock samples (b) Location of brick and mortar samples (Şerife Özata Archive, 2023)

standing. The fallen rock, mortar and brick samples were collected from areas indicated in **F. 5** without damaging the structure, and the properties of these materials were examined. While the samples were taken, care was taken to ensure that they represent the overall structure. The rock samples were named R1 and R2 (**F. 8a**), mortar sample entitled as M1 and the brick sample taken from the entrance was termed as B1 (**F. 8b**). The mechanical, physical and chemical properties of them were determined by the following experiments.

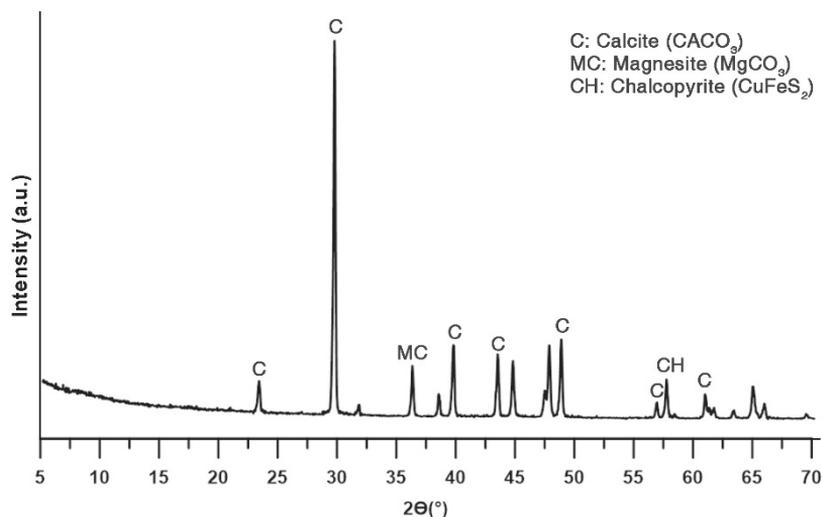
F. 9: X-Ray diffraction of the rock (Prepared by Şerife Özata and Büşra Aktürk)

In **F. 9**, the peaks obtained as a result of X-Ray diffractometry are shared. International Center for Diffraction Data (ICDD) and some other sources⁵⁵ were used for peak analysis. The rock has abundant calcite (CaCO_3) peaks as its main component. The observed small peaks of magnesite (MgCO_3) and chalcopyrite (CuFeS_2) confirm the XRF results. XRD results also approve that the material is limestone.

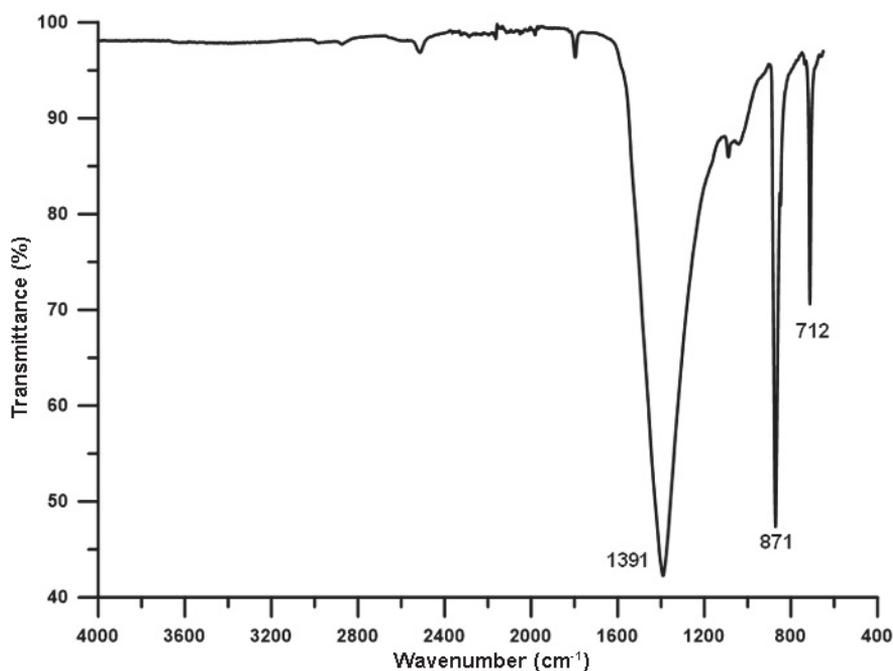
F. 10: FTIR spectrum of the rock (Prepared by Büşra Aktürk and Şerife Özata)

In this Fourier-transform infrared spectroscopy (FTIR) graph, in **F. 10**, prominent peaks were seen in wave numbers of 712 cm^{-1} , 871 cm^{-1} , and 1391 cm^{-1} , respectively. It is a typical calcite absorption band seen at 712 cm^{-1} ⁵⁶. The peak around 871 cm^{-1} is attributed to the out-of-plane bending vibration of CO_3^{2-} ⁵⁷. The peaks seen at approximately 871 cm^{-1} and 1391 cm^{-1} wave numbers generally represent O-C-O tension bonds belonging to the $\nu_3\text{-CO}_3^{2-}$ and $\nu_2\text{-CO}_3^{2-}$ carbonate groups, respectively, and indicate the presence of high-carbonate calcite⁵⁸. The presence of the main oxide, CaO, confirms the presence of CaCO_3 compounds with carbonate phases in the sample.

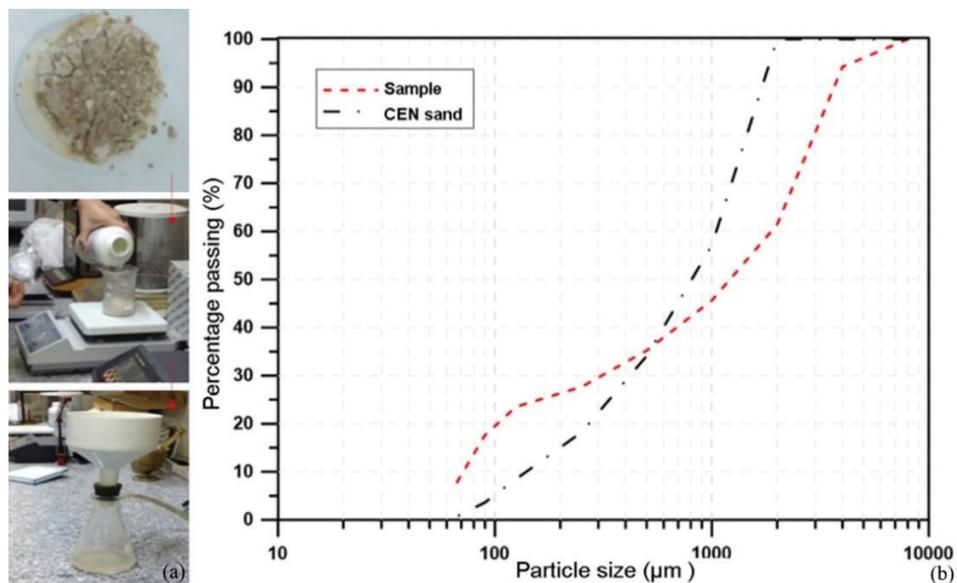
F. 11: (a) Acid treatment steps (Taken by Büşra Aktürk) (b) Granulometry results of aggregate (Prepared by Büşra Aktürk and Şerife Özata)

50 g of the mortar sample obtained from the monastery was carefully crushed by hand. HCl (1N) was added and mixed in a magnetic stirrer at 1000 rpm for 60 minutes. At the end of this period, the remaining aggregate was filtered under constant pressure with a glass microfiber filter (**F. 11a**) and then dried at 105 °C for 24 hours. The dry aggregate was weighed and sieved. Sieve analysis results are shown in **F. 11b**. As a result of the experiment, the binder/aggregate ratio was found to be 1:2. In the literature, it is known that the binder/aggregate ratios are in various ratios such as 1:2, 2:3 and 1:1 as a result of the analyses carried out on the original mortar samples taken from the historical buildings built in the Roman, Eastern Roman, Seljuk and Ottoman periods⁶¹.
